## 석면해체 · 제거 사업장의 석면비산 측정 위치 및 결과

| 측정 결과 | | | | |
|---|---|---|---|---|
| 측정 일시 | 2018.09.05 | | | |

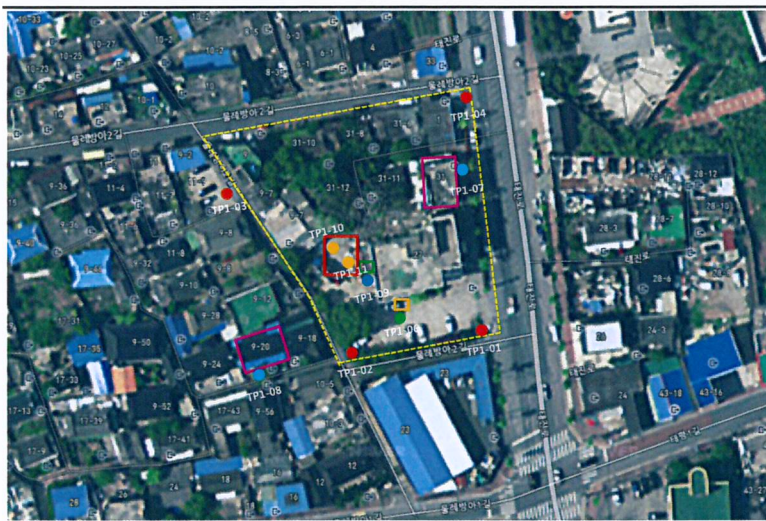
측정 지점 위치(도식도)

| 측정 결과 | | | | |
|---|---|---|---|---|
| | TP1-01 | 부지경계선(남동) | 0.0013 | 기준치미만(0.01f/cc) |
| | TP1-02 | 부지경계선(남서) | 0.0005 | 기준치미만(0.01f/cc) |
| | TP1-03 | 부지경계선(북서) | 0.0006 | 기준치미만(0.01f/cc) |
| | TP1-04 | 부지경계선(북동) | 0.0004 | 기준치미만(0.01f/cc) |
| | TP1-05 | 위생설비 입구 | 0.0081 | 기준치미만(0.01f/cc) |
| | TP1-06 | 음압기 통과 공기 배출구 | 0.0034 | 기준치미만(0.01f/cc) |
| | TP1-07 | 거주자 주거지역1 | 0.0014 | 기준치미만(0.01f/cc) |
| | TP1-08 | 거주자 주거지역2 | 0.0022 | 기준치미만(0.01f/cc) |
| | TP1-09 | 폐기물 반출구 | 0.0058 | 기준치미만(0.01f/cc) |
| | TP1-10 | 폐기물 보관지점1 | 0.0028 | 기준치미만(0.01f/cc) |
| | TP1-11 | 폐기물 보관지점2 | 0.0030 | 기준치미만(0.01f/cc) |
