1. 측정결과 - 2023. 01. 05.

## 2. 측정사진

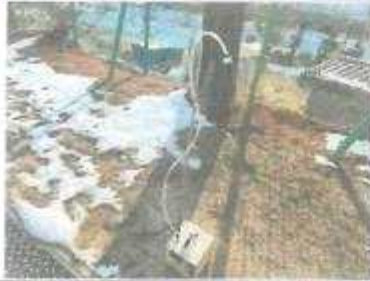
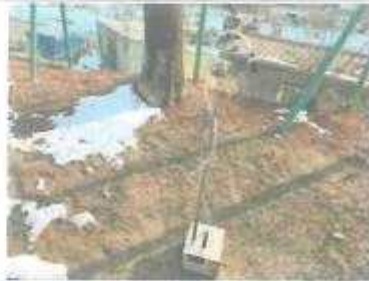
| 측정지점 | 비산측정 시작 사진 | 비산측정 종료 사진 | 결과(I/cc) |
|---|---|---|---|
| 부지경계선1 | <br>측정 시작 시간 09:46 | <br>측정 종료 시간 13:51 | 0.0022 |

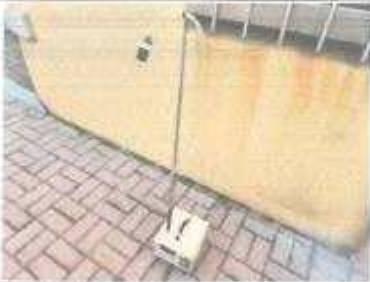
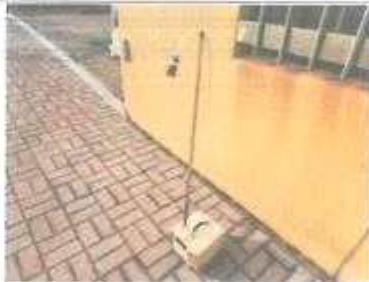
| 측정지점 | 비산측정 시작 사진 | 비산측정 종료 사진 | 결과(I/cc) |
|---|---|---|---|
| 부지경계선2 | <br>측정 시작 시간 09:47 | <br>측정 종료 시간 13:52 | 0.0018 |

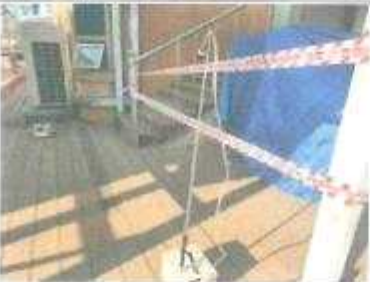
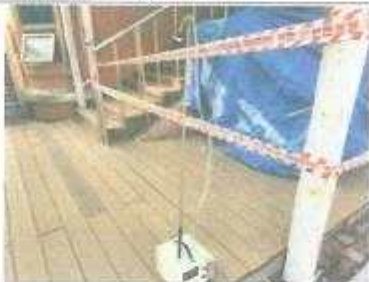
| 측정지점 | 비산측정 시작 사진 | 비산측정 종료 사진 | 결과(I/cc) |
|---|---|---|---|
| 부지경계선3 | <br>측정 시작 시간 09:48 | <br>측정 종료 시간 13:53 | 0.0016 |

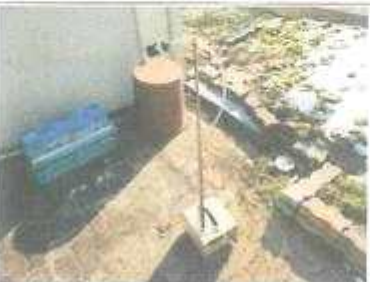
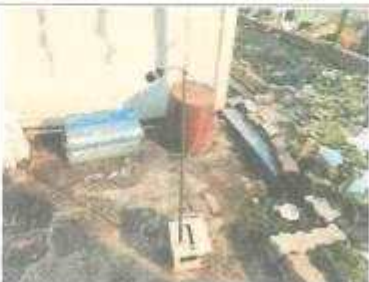
| 측정지점 | 비산측정 시작 사진 | 비산측정 종료 사진 | 결과(I/cc) |
|---|---|---|---|
| 부지경계선4 | <br>측정 시작 시간 09:49 | <br>측정 종료 시간 13:54 | 0.0020 |

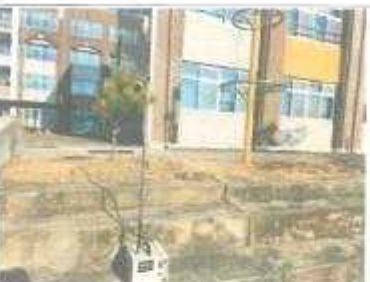
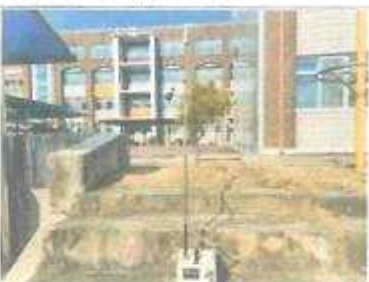
| 측정지점 | 비산측정 시작 사진 | 비산측정 종료 사진 | 결과(I/cc) |
|---|---|---|---|
| 작업장주변 | <br>측정 시작 시간 10:32 | <br>측정 종료 시간 12:37 | 0.0036 |

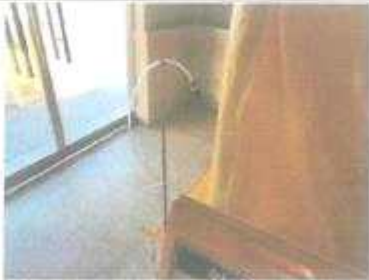
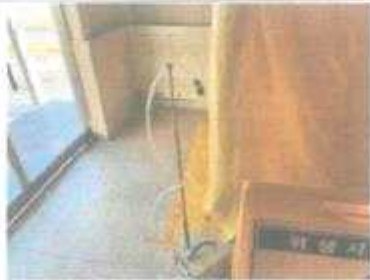
| 측정지점 | 비산측정 시작 사진 | 비산측정 종료 사진 | 결과(l/cc) |
|---|---|---|---|
| 위생설비<br>입구 | | | 0.0026 |
| | 측정 시작 시간 09:41 | 측정 종료 시간 10:26 | |

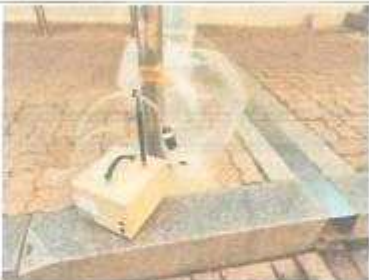
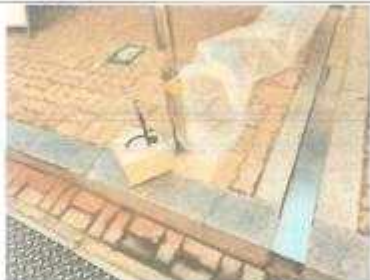
| 측정지점 | 비산측정 시작 사진 | 비산측정 종료 사진 | 결과(l/cc) |
|---|---|---|---|
| 음압기공기<br>배출구 | | | 0.0029 |
| | 측정 시작 시간 09:44 | 측정 종료 시간 10:29 | |

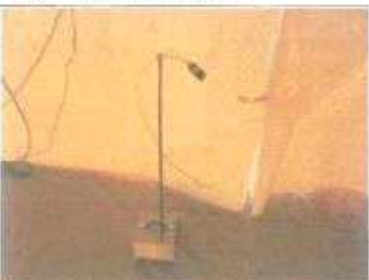
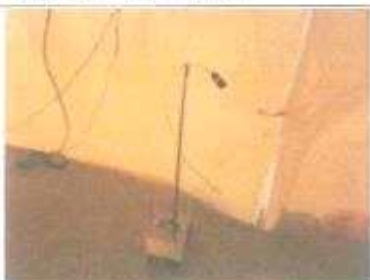
| 측정지점 | 비산측정 시작 사진 | 비산측정 종료 사진 | 결과(l/cc) |
|---|---|---|---|
| 폐기물<br>반출구 | | | 0.0029 |
| | 측정 시작 시간 10:46 | 측정 종료 시간 11:31 | |

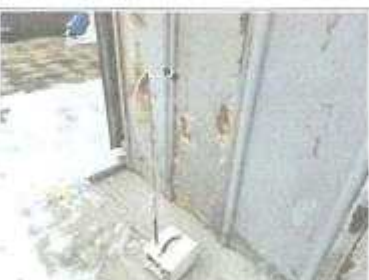
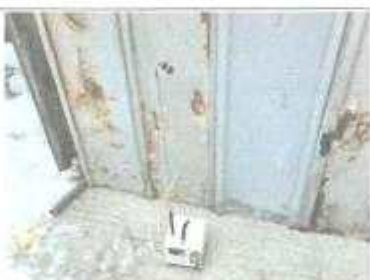
| 측정지점 | 비산측정 시작 사진 | 비산측정 종료 사진 | 결과(l/cc) |
|---|---|---|---|
| 폐기물<br>보관지점1 | | | 0.0029 |
| | 측정 시작 시간 11:47 | 측정 종료 시간 12:32 | |

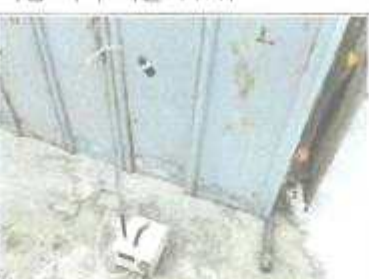
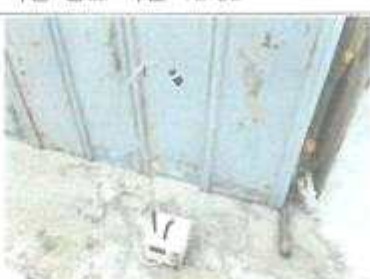
| 측정지점 | 비산측정 시작 사진 | 비산측정 종료 사진 | 결과(l/cc) |
|---|---|---|---|
| 폐기물<br>보관지점2 | | | 0.0026 |
| | 측정 시작 시간 11:47 | 측정 종료 시간 12:32 | |

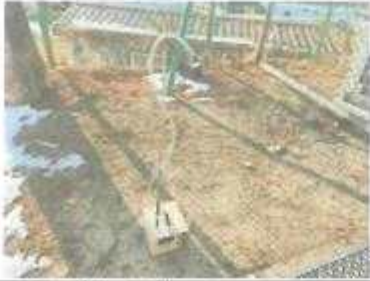
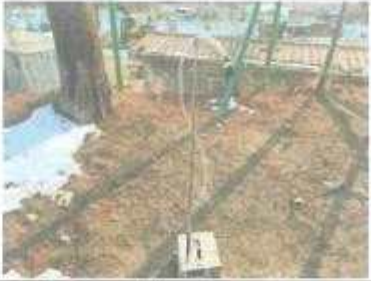
| 측정지점 | 비산측정 시작 사진 | 비산측정 종료 사진 | 결과(t/cc) |
|---|---|---|---|
| 부지경계선1 | | | 0.0020 |
| | 측정 시작 시간 10:06 | 측정 종료 시간 14:11 | |

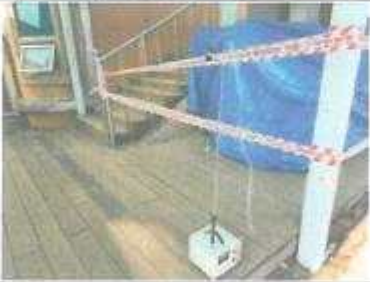
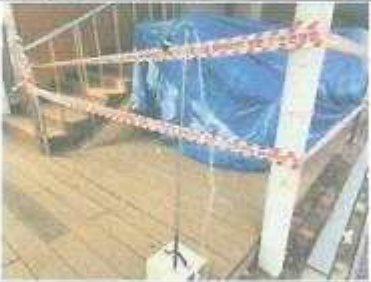
| 측정지점 | 비산측정 시작 사진 | 비산측정 종료 사진 | 결과(t/cc) |
|---|---|---|---|
| 부지경계선2 | | | 0.0018 |
| | 측정 시작 시간 10:07 | 측정 종료 시간 14:12 | |

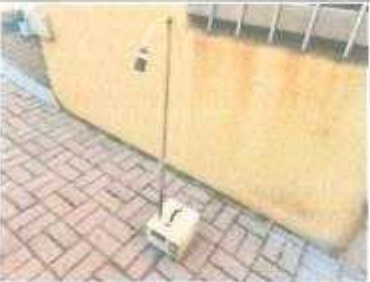
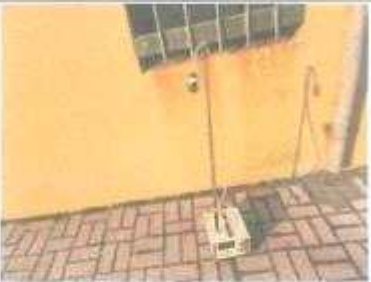
| 측정지점 | 비산측정 시작 사진 | 비산측정 종료 사진 | 결과(t/cc) |
|---|---|---|---|
| 부지경계선3 | | | 0.0016 |
| | 측정 시작 시간 10:08 | 측정 종료 시간 14:13 | |

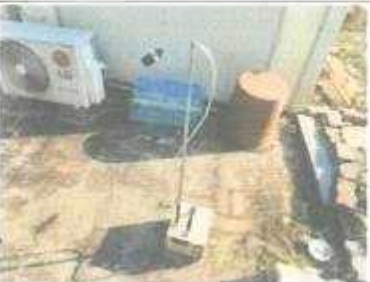
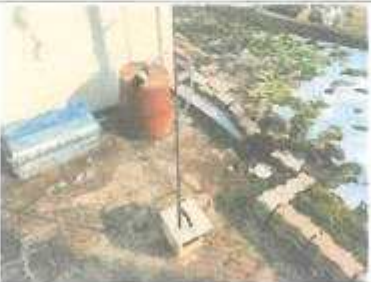
| 측정지점 | 비산측정 시작 사진 | 비산측정 종료 사진 | 결과(t/cc) |
|---|---|---|---|
| 부지경계선4 | | | 0.0020 |
| | 측정 시작 시간 10:10 | 측정 종료 시간 14:15 | |

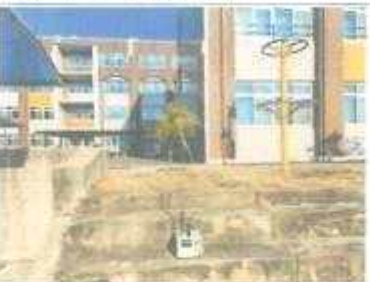
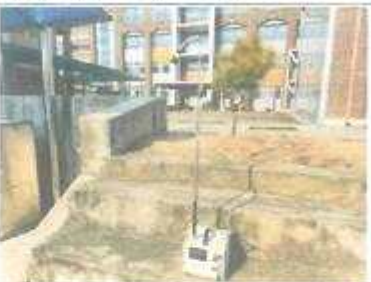
| 측정지점 | 비산측정 시작 사진 | 비산측정 종료 사진 | 결과(t/cc) |
|---|---|---|---|
| 작업장주변 | | | 0.0032 |
| | 측정 시작 시간 10:26 | 측정 종료 시간 12:31 | |

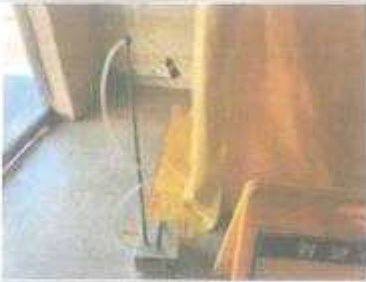
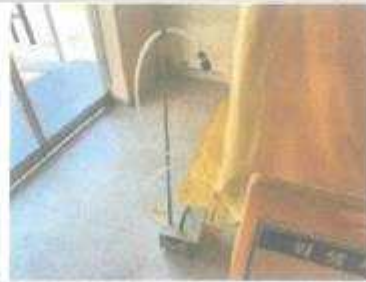
| 측정자점 | 비산측정 시작 사진 | 비산측정 종료 사진 | 결과(l/cc) |
|---|---|---|---|
| 위생설비<br>입구 | | | 0.0026 |
| | 측정 시작 시간 10:18 | 측정 종료 시간 11:03 | |

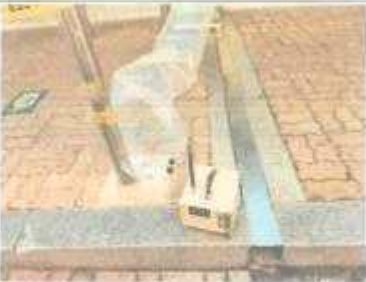
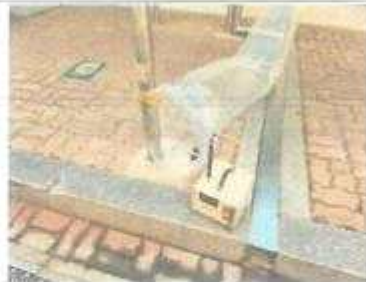
| 측정자점 | 비산측정 시작 사진 | 비산측정 종료 사진 | 결과(l/cc) |
|---|---|---|---|
| 응압기공기<br>배출구 | | | 0.0033 |
| | 측정 시작 시간 10:20 | 측정 종료 시간 11:05 | |
